# No. 1452545.5R

SAMPLE DESCRIPTION:  
Oslo plank samples fixed to a clear Perspex base using:  
- 88 Cementitious Feather finish and absorbent mat used to prepare Perspex to receive planks.  
- UZIN KE66 wet set, dispersion based adhesive (Hard Set).

## ISO 4760:2022(E) - LAMINATE FLOORING – TOPICAL MOISTURE RESISTANCE – ASSEMBLED JOINT (MODIFIED)

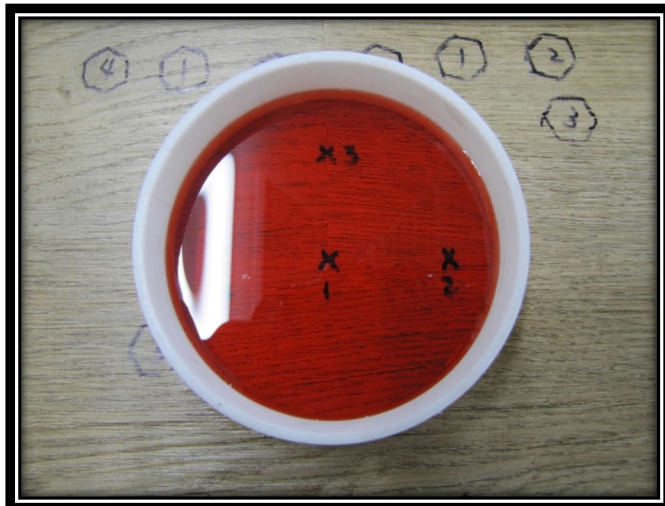
24 Hrs With Water

The underside of the sample was inspected through the clear Perspex to enable detection of any dye penetration through the sample .

Observations:	Specimen 1	Specimen 2	Specimen 3
Migration of water along the upper surface:	No	No	No
Migration of water to the underside:	No	No	No
